**Final Report**  
**STUDY METHODS TO STANDARDIZE**  
**THERMOGRAPHY NDE**

Contract Number: NAS8-38609  
Delivery order: 174

February, 1998

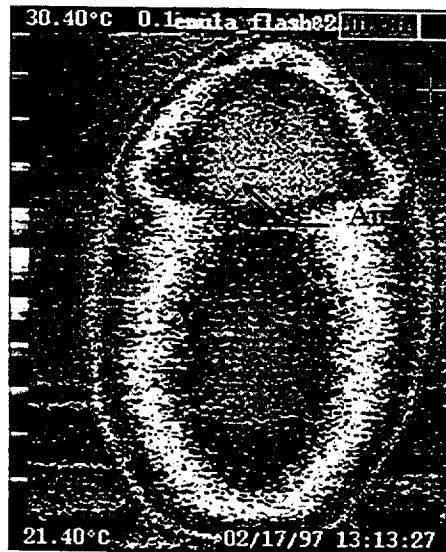
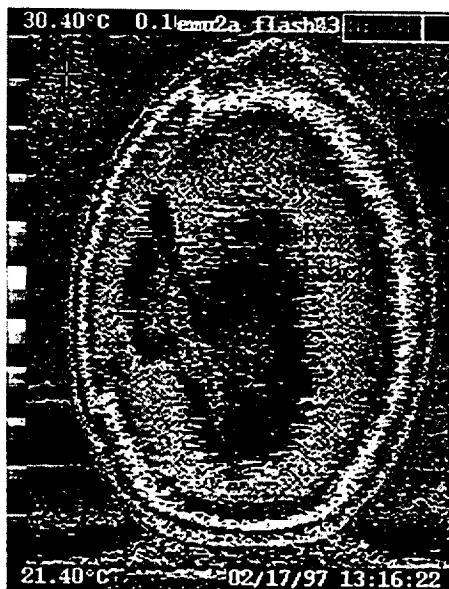
In order to determine if the sack was torn or in place the egg was imaged on its side and on end. As seen in the first set of images, the air pocket moves indicating that the sack is ruptured. On the other hand, the second set of images show that the sack remains in position as the egg is turned.

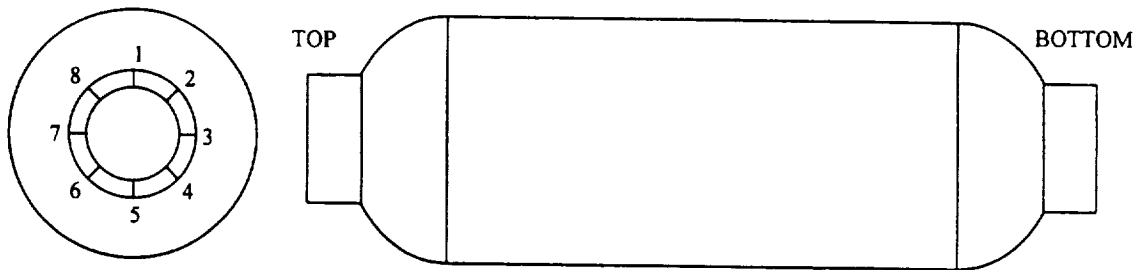
The thermal indications in the hoop region of the side views indicates some possible scattered disbonding of the gr/ep shell from the inner liner. Small hot patches can be seen in each of the side view images. The hot regions would indicate an area where heat from the flash unit was trapped on the surface by a insulating air pocket "disbond" below it. These indications tend to be in the quarter inch square size range. More severe thermal indications are present in the transition region between the hoop and dome. A band of disbonds appears to wrap all the way around the vessel. Some of these transition region abnormalities grow into the hoop and dome region, in the wind direction, which is typical of delamination/disbond growth in filament wound structures.

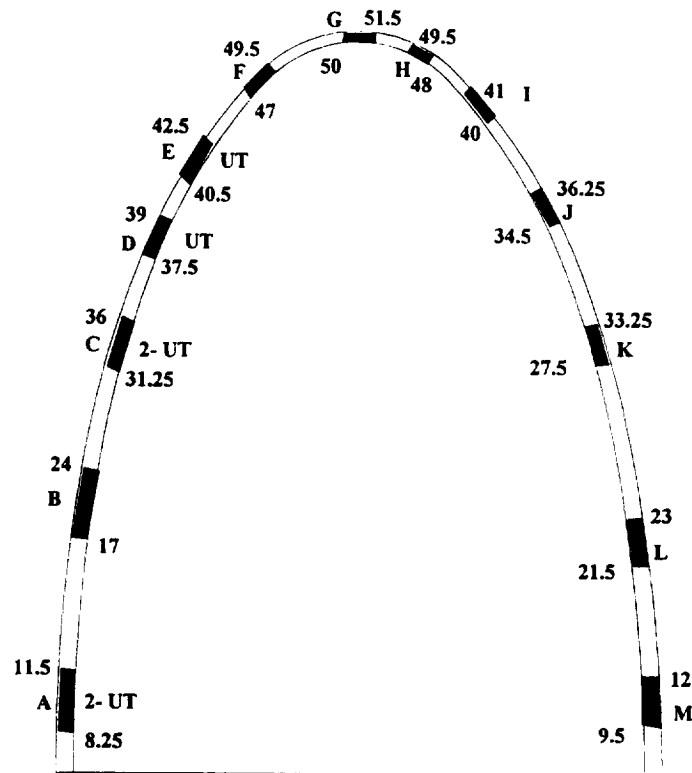
Defect map

The thermographic inspection yielded 13 potential regions of porosity, including the six previously located by ultrasonics. The following figure outlines the six regions found by UT and the 13 found by thermography. These thirteen regions are also shown on the resulting thermograms.

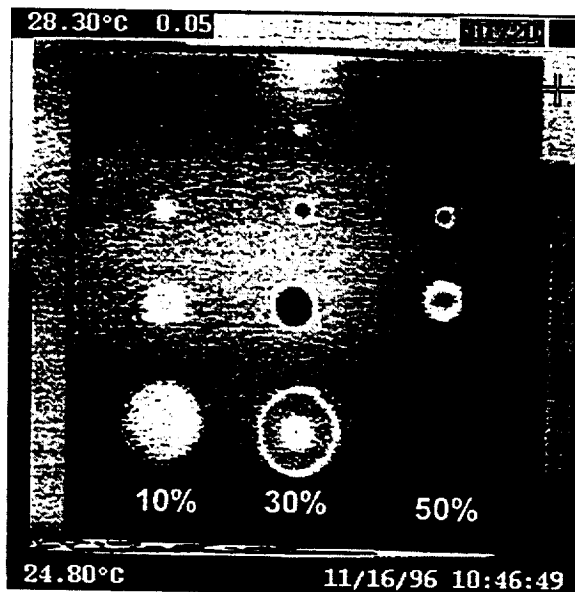
F190 (Back side)

All scheduled defects were found when the back side of the panel "the opposite side from the label" was imaged. These defects are at a depth of 10%, 30% and 50% into the panel.

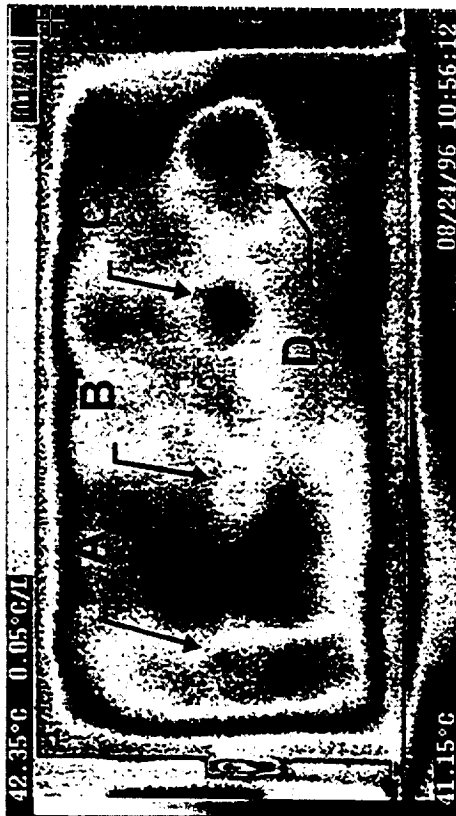
Image 1 was acquired with front side heating by a hand held heat gun. The time delay between images was set to 100 msec and images 2 through 21 were archived. In this image all four scheduled defects can be seen. When specimen A was excited with flash heating only the largest three defects could be found.

(1) Specimen A - Front side heating by heat gun

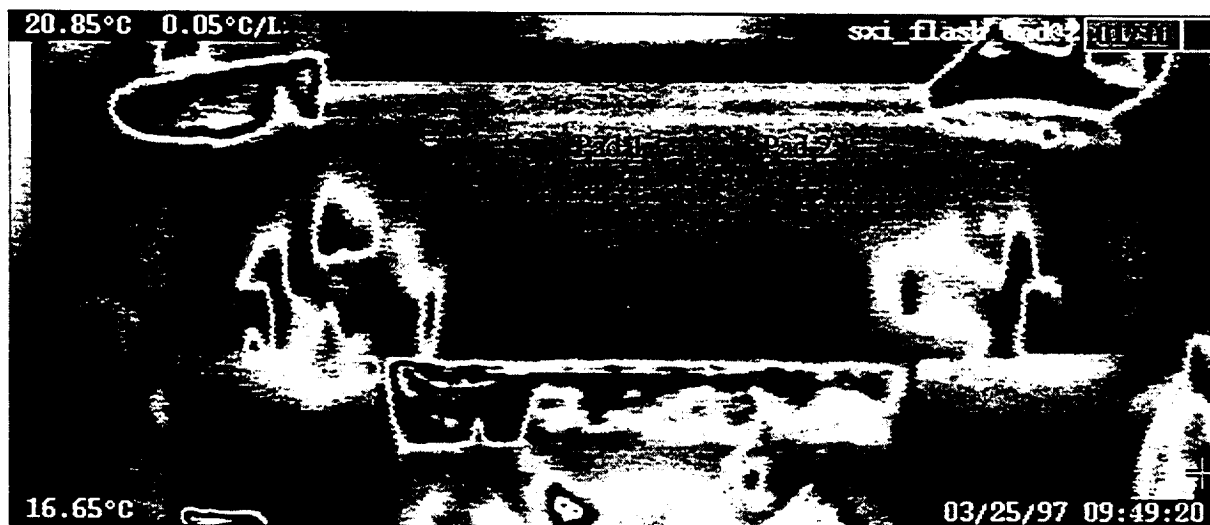
The images (both flash and manual heating) of where attachment pad 1 and 2 tore loose clearly show the regions where the tube delaminated upon failure. It was difficult to view the bondline during flash heating. During manual heating though, several discontinuities can clearly be seen. These discontinuities may be cracks "delaminations" formed due to the bending moment applied to the joint when the upper pads failed. The joint would need to be inspected with other NDE techniques such as ultrasonics or x-ray to verify these conclusions.

Top pad attach points (Flash heating)

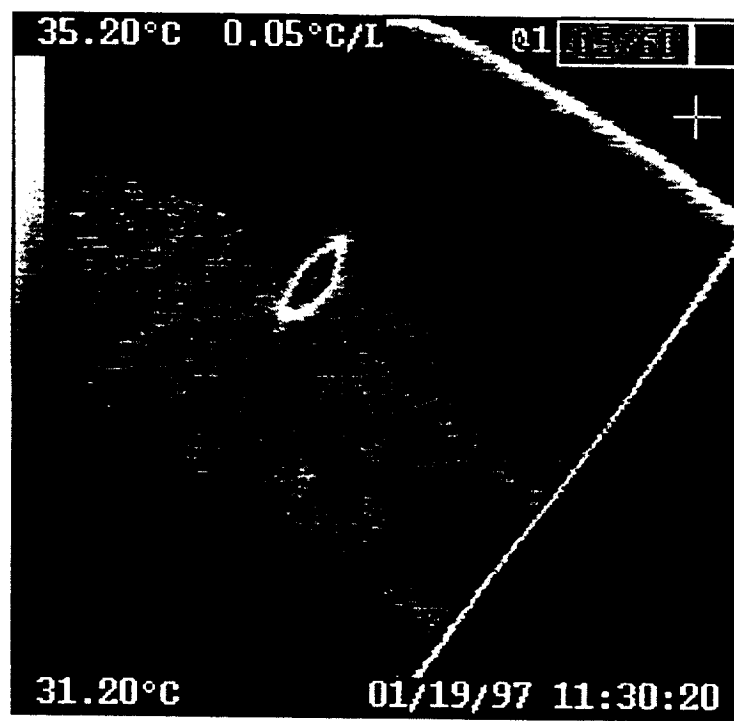
The only defects located or identified was a grinding mark, approximately 0.5 inch square, on the inside of the tube. The mark appears to be almost all the way through the tube, but is not visible from the outside. No scheduled defects were planned for this component.

Close-up image of tool mark
